Probe Connector Repair Tool

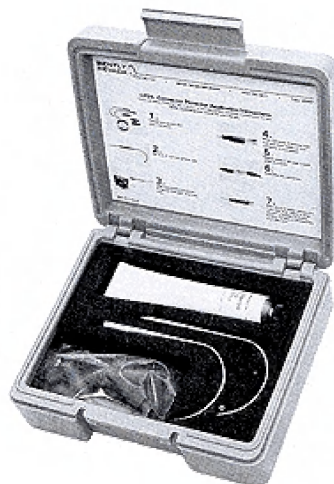
This tool consists of an aluminum cylinder with a knurled grip area containing two precision steel inserts. These inserts are positioned to simulate each of the two mating connectors of our probes and cables. One end of the tool contains a simulated male connector and the other end contains a simulated female connector. This allows you to repair either male or female proximity probe connectors.

Miniature coaxial connectors have stainless steel outer shells that are extremely durable. In contrast, the gold-plated center conductor is less resilient due to its material and the tight tolerances around it. If this conductor is bent off center, the Connector Repair Tool can restore it to its proper position, saving the connector and saving you time and money.

In either situation, the Connector Repair Tool could be used to re-align the conductors and make the connection. The tool can be easily stored in the Connector Protector Kit which is another excellent accessory to have on hand during routine transducer service or maintenance. This kit was recently reduced 25 percent. When you place your next "spare parts" order, request the Connector Repair Tool with the order. The low price of the tool could pay for itself the first time you use it!
